AIRCRAFT ACCIDENT  
IDENTIFICATION  
NO.

**601 25 101**

NAVAL AVIATION SAFETY CENTER

1. AIRCRAFT ACCIDENT BOARD APPOINTED BY <b>CO, NAS QUONSET POINT</b>	2. SERIAL NO <b>1-66A</b>	3. DTG (LOCAL) OF MISHAP <b>251332 JAN</b>	4. MODEL AIRCRAFT <b>A4B</b>	5. BUREAU NUMBER <b>142095</b>
6. TO: Commander, Naval Aviation Safety Center	7. VIA: <b>COMFAIRQUONSET</b> <b>COMNAVIAIRLANT</b>	8. 9. LOCATION OF MISHAP <b>90' short of sea wall, 300' short of R/W 34</b>	10. DAMAGE <b>ALPHA</b>	
		11. TIME OF DAY <b>1332</b>	12. TIME IN FLIGHT <b>00:04</b>	13. FLIGHT CODE <b>IL</b>
		14. CLEARED <b>FROM: NAS QUONSET</b>	<b>TO: NAS QUONSET</b>	
		15. TYPE CLEARANCE <b>VFR LOCAL</b>	16. AIRSPEED <b>113E</b>	17. A/C WEIGHT <b>Est. 14177</b>
18. BRIEF DESCRIPTION OF MISHAP <b>Engine seizure following internal explosion. A/C landed 300' short of R/W 34 in water</b>	19. ELEVATION AT TIME OF MISHAP <b>SL 0 TERRAIN Water</b>

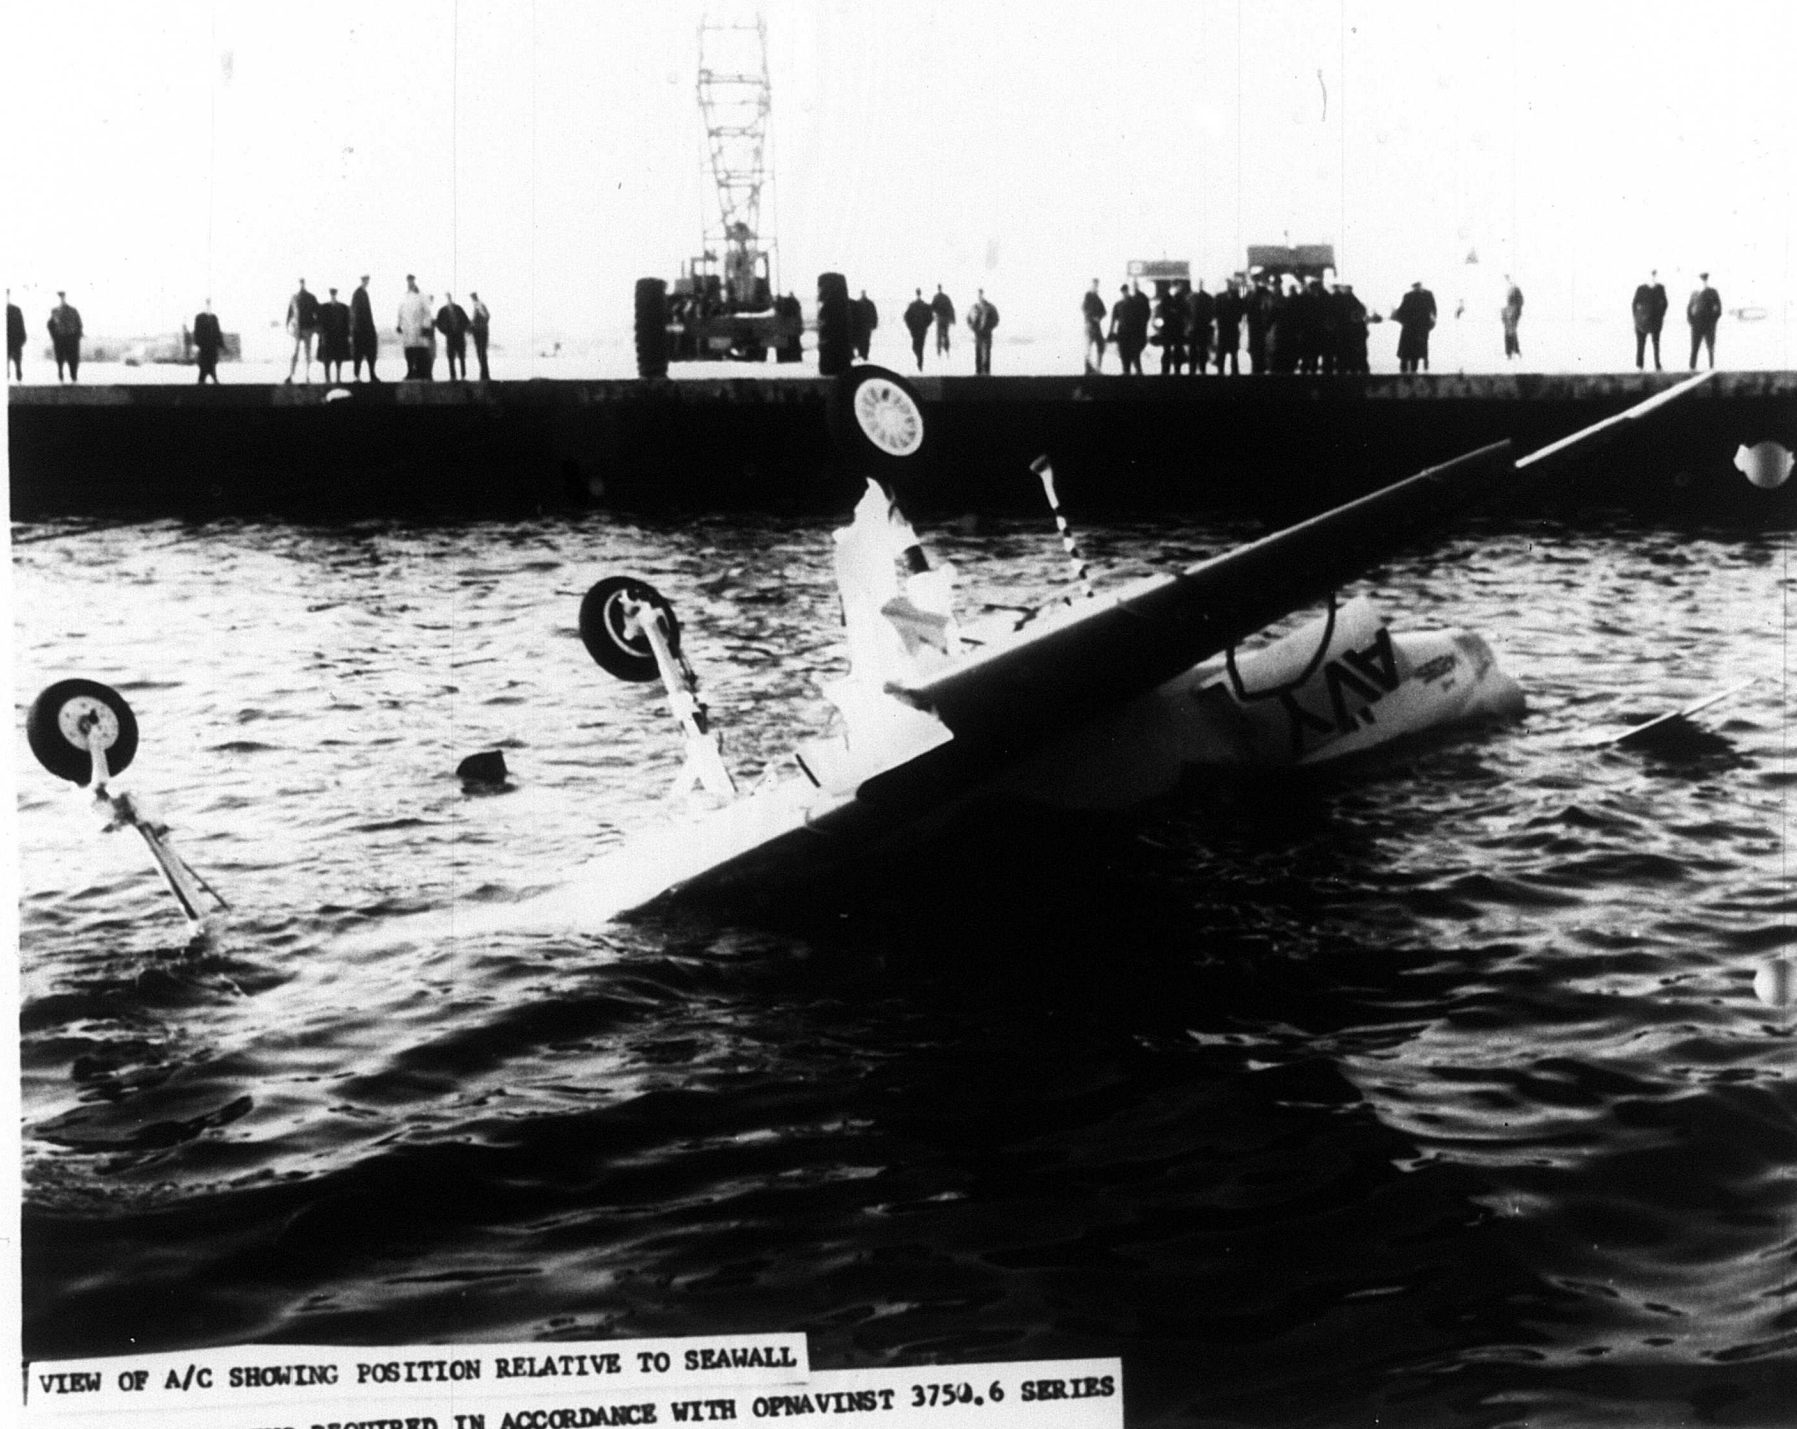
ENCLOSURE (3)

VIEW OF A/C SHOWING POSITION RELATIVE TO SEAWALL  
 SPECIAL HANDLING REQUIRED IN ACCORDANCE WITH OPNAVINST 3750.6 SERIES

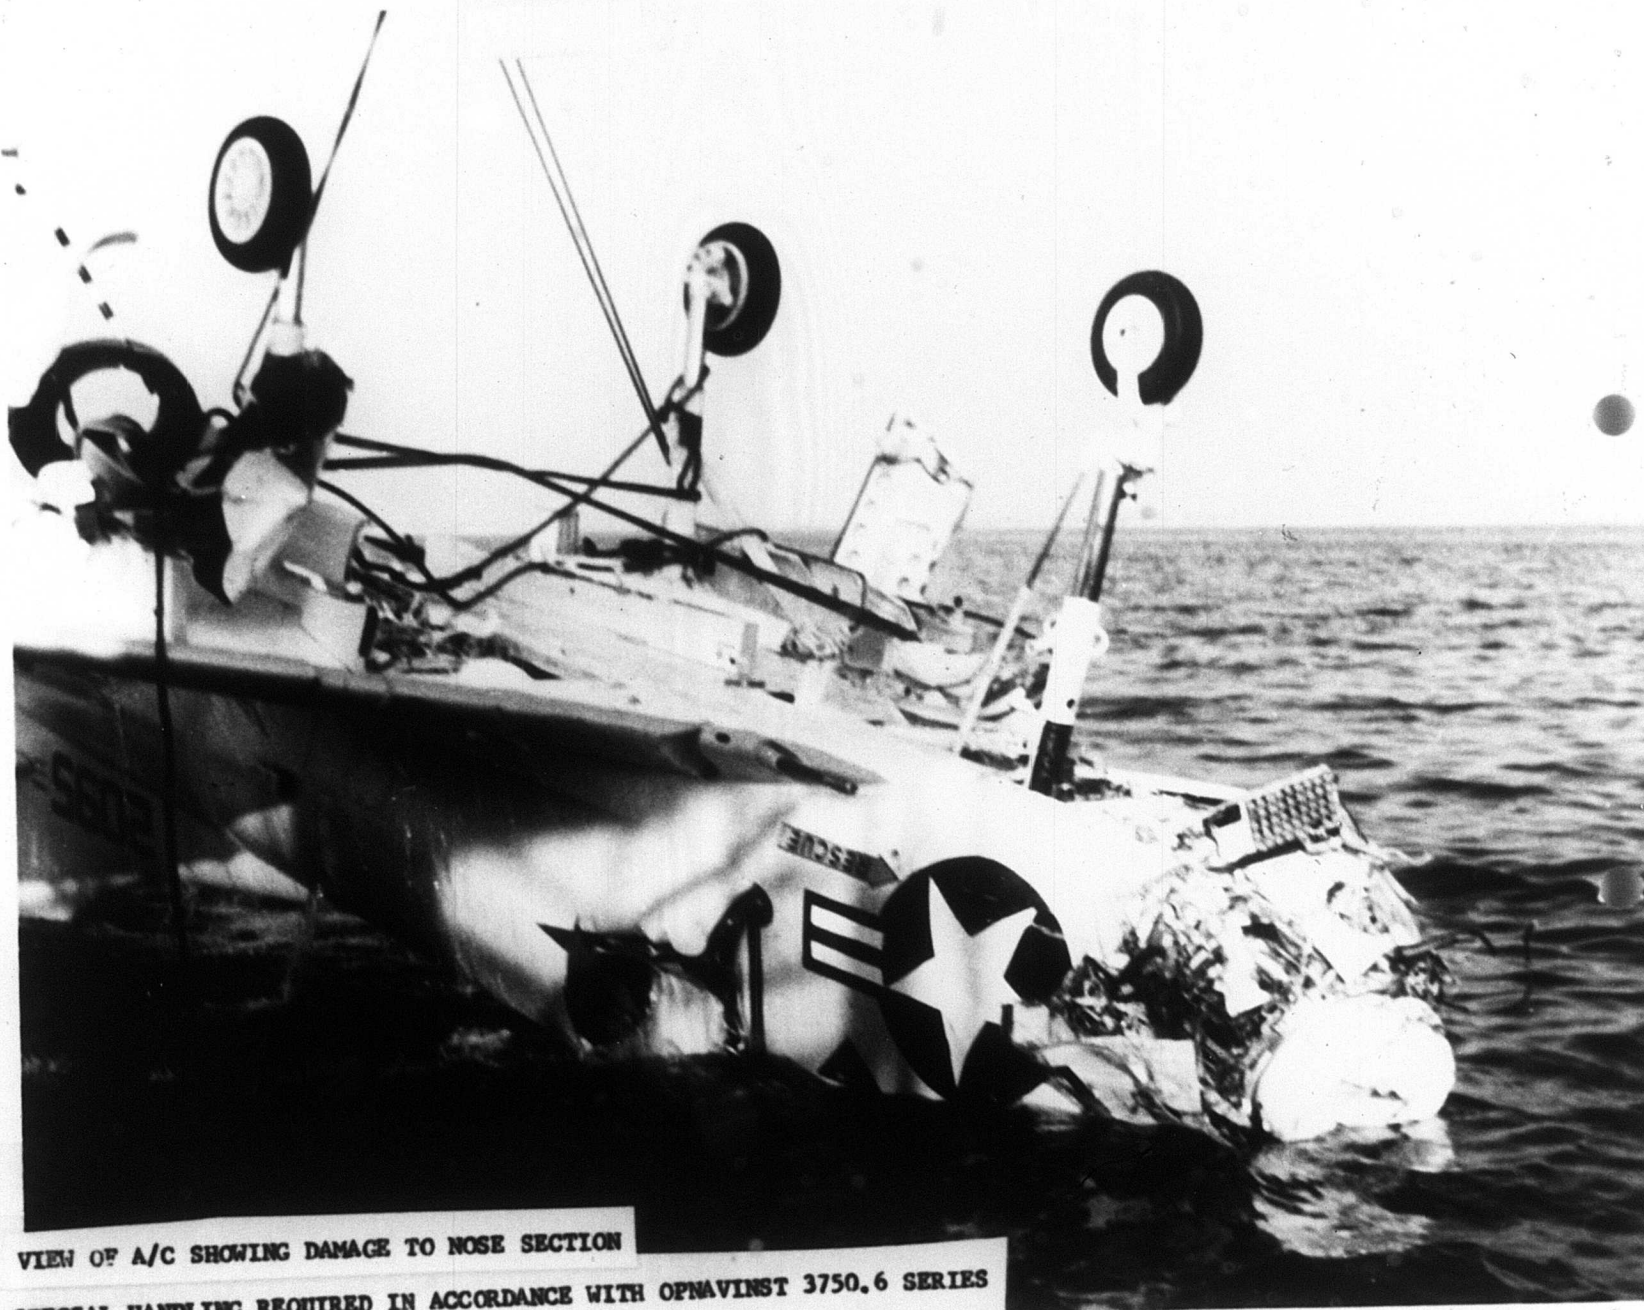
ENCLOSURE (11)

All of the remaining attached portion of the fuselage nose to station 128 was distorted toward the bottom of the fuselage (see enclosure (11)). As the aircraft continued beyond the vertical position to an inverted position (see enclosure (12)), the starboard and port engine air inlet scoops were distorted and bent from stations 125 to 180. Many rivets were broken out in these areas.

VIEW OF A/C SHOWING DAMAGE TO NOSE SECTION

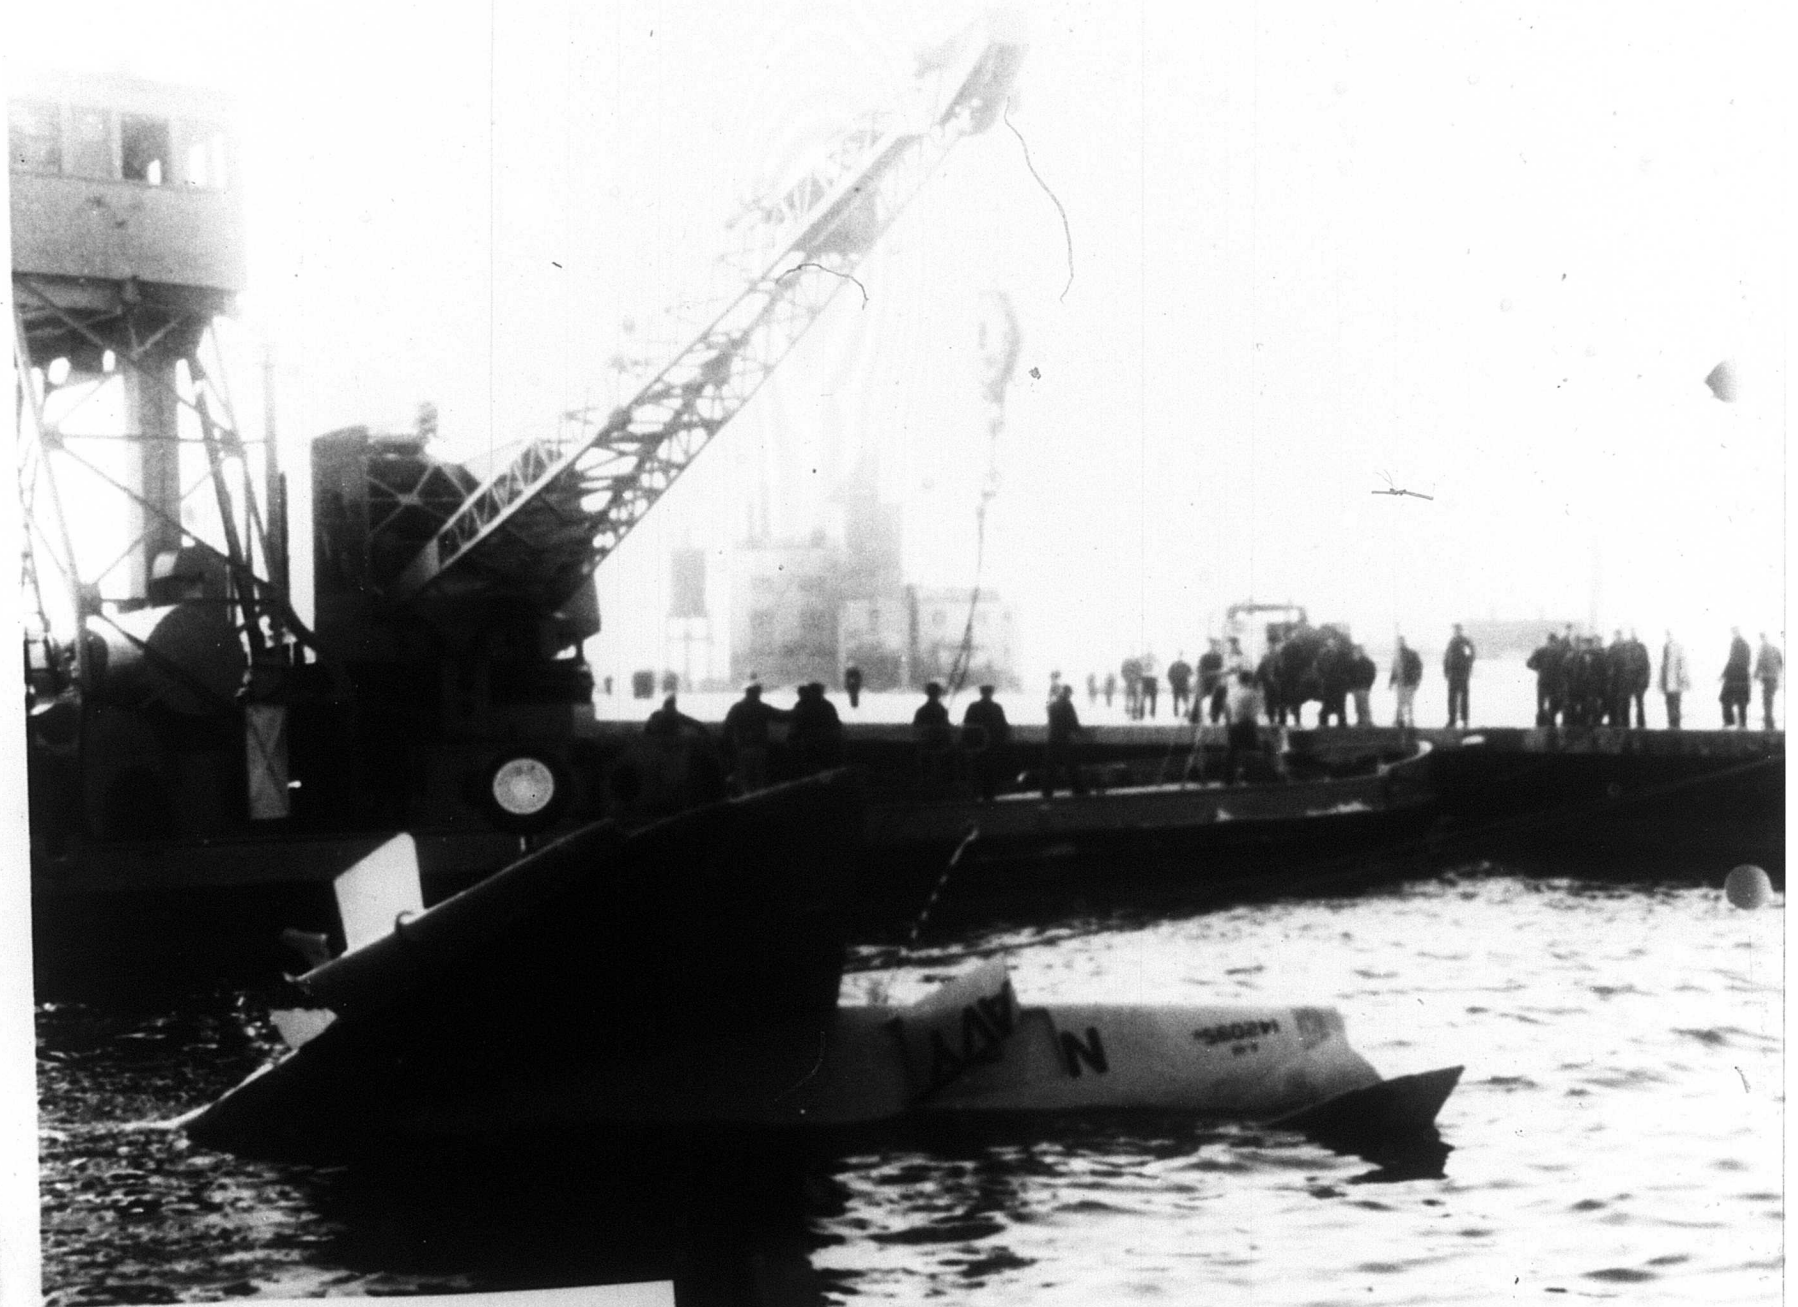
VIEW OF A/C BEING HOISTED ABOARD YSD-34  
SPECIAL HANDLING REQUIRED IN ACCORDANCE WITH OPNAVINST 3750.6 SERIES

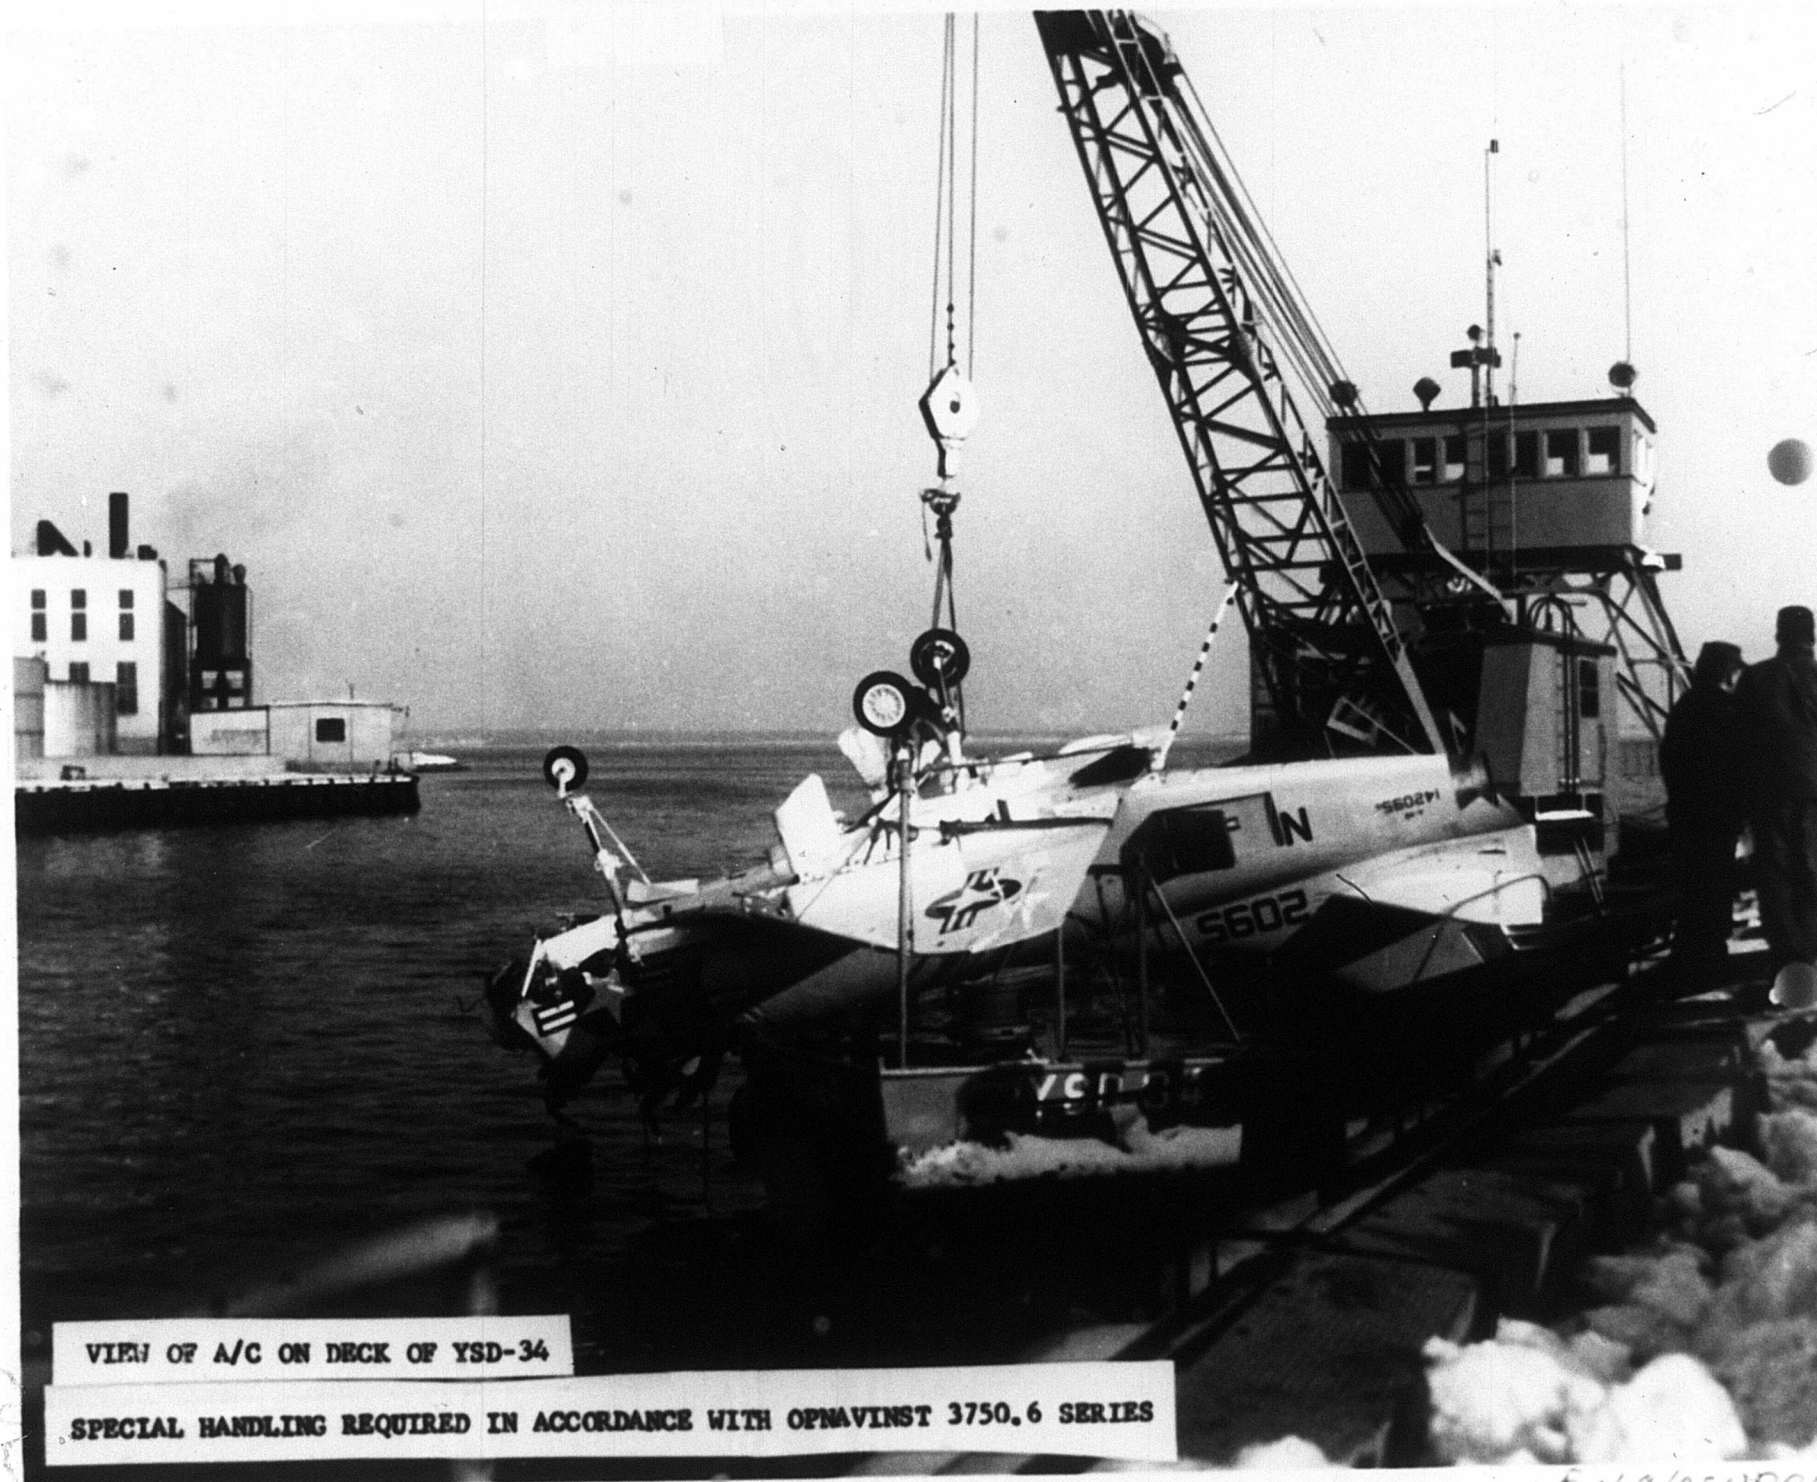
VIEW OF A/C ON DECK OF YSD-34

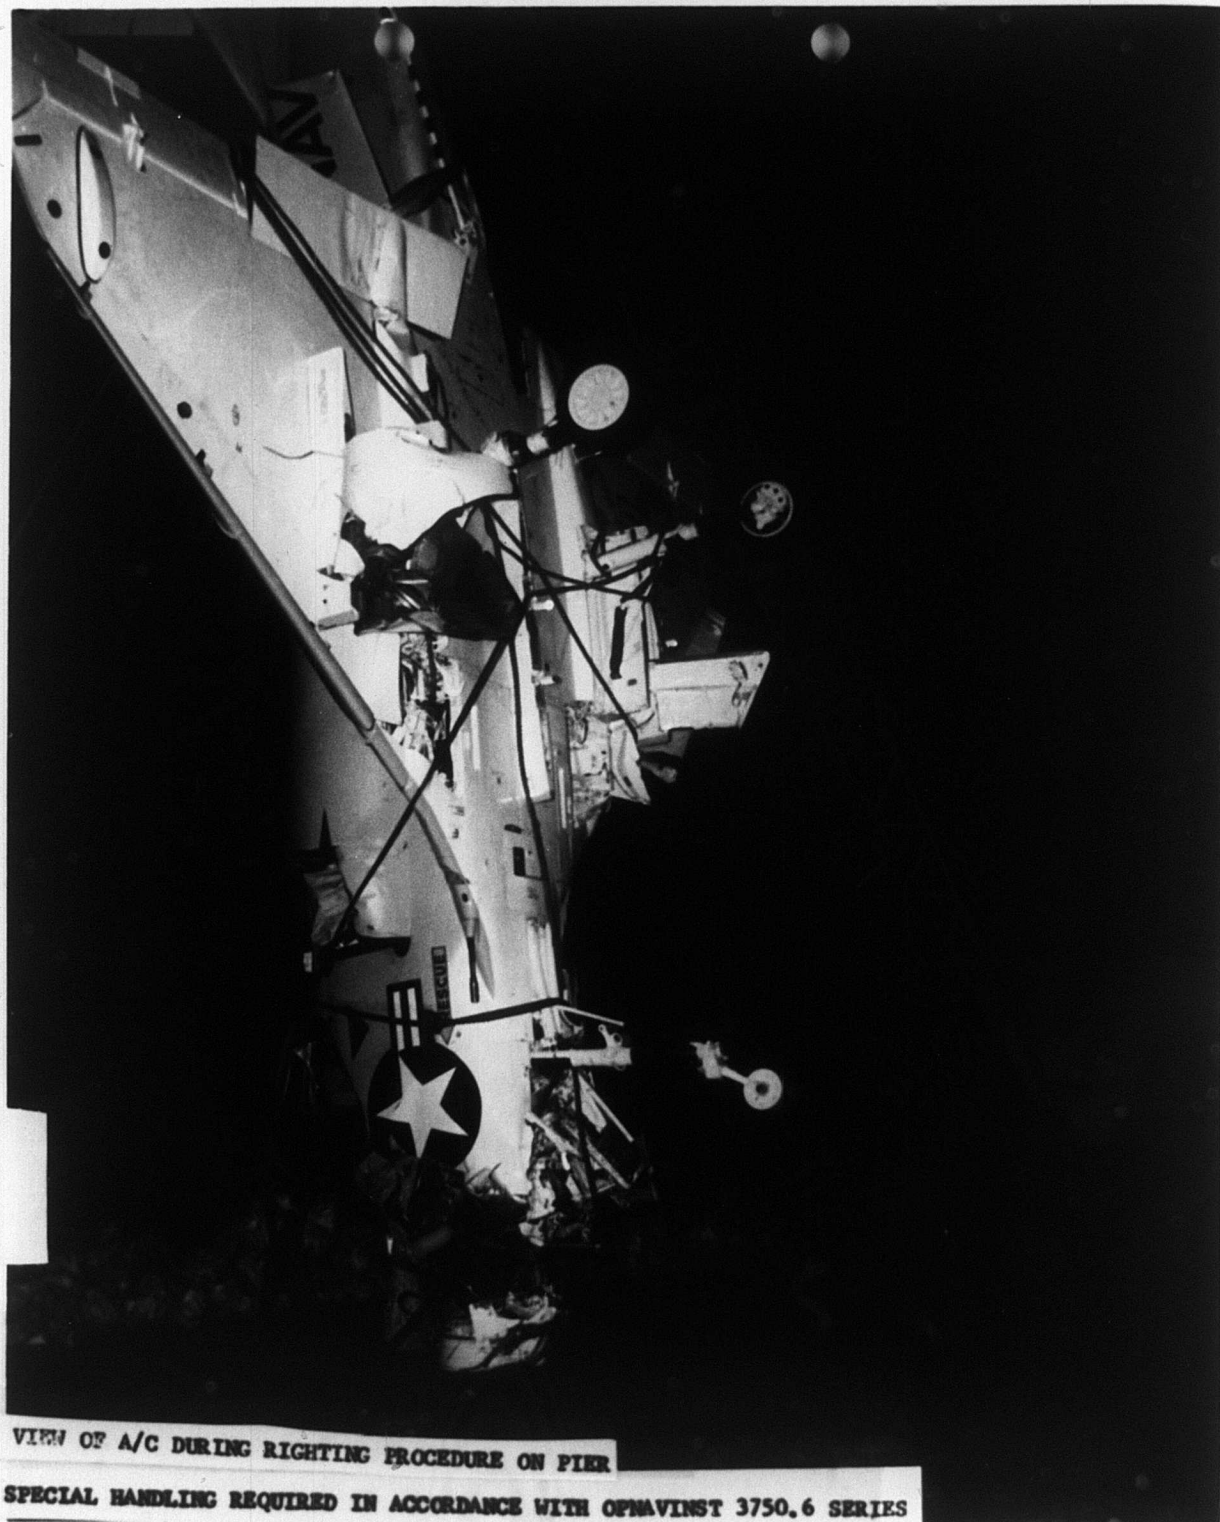
ENCL (14)

Upon arrival at the carrier pier, an additional floating crane and a PWD mobile crane were used in off-loading and turning the aircraft upright (see enclosure (14)). During the off-loading operation, the following damage was inflicted:

- a. The forward fuselage starboard was torn from the aircraft exposing the fuselage fuel cell.
- b. The nose gear shock strut upper attach fittings were broken loose from the fuselage.
- c. The aft fuselage, stations 342 to 400, was buckled and torn.
- d. The speed brakes, port and starboard, were buckled and bent along their aft edge.
- e. The elevators, port and starboard, were buckled from stations X50 to X66.

VIEW OF A/C DURING RIGHTING PROCEDURE ON PIER
